خاک و آتش: افسون کوره‌ی سفال

خبر پیدا شدن کوره

آسیب‌شناسی

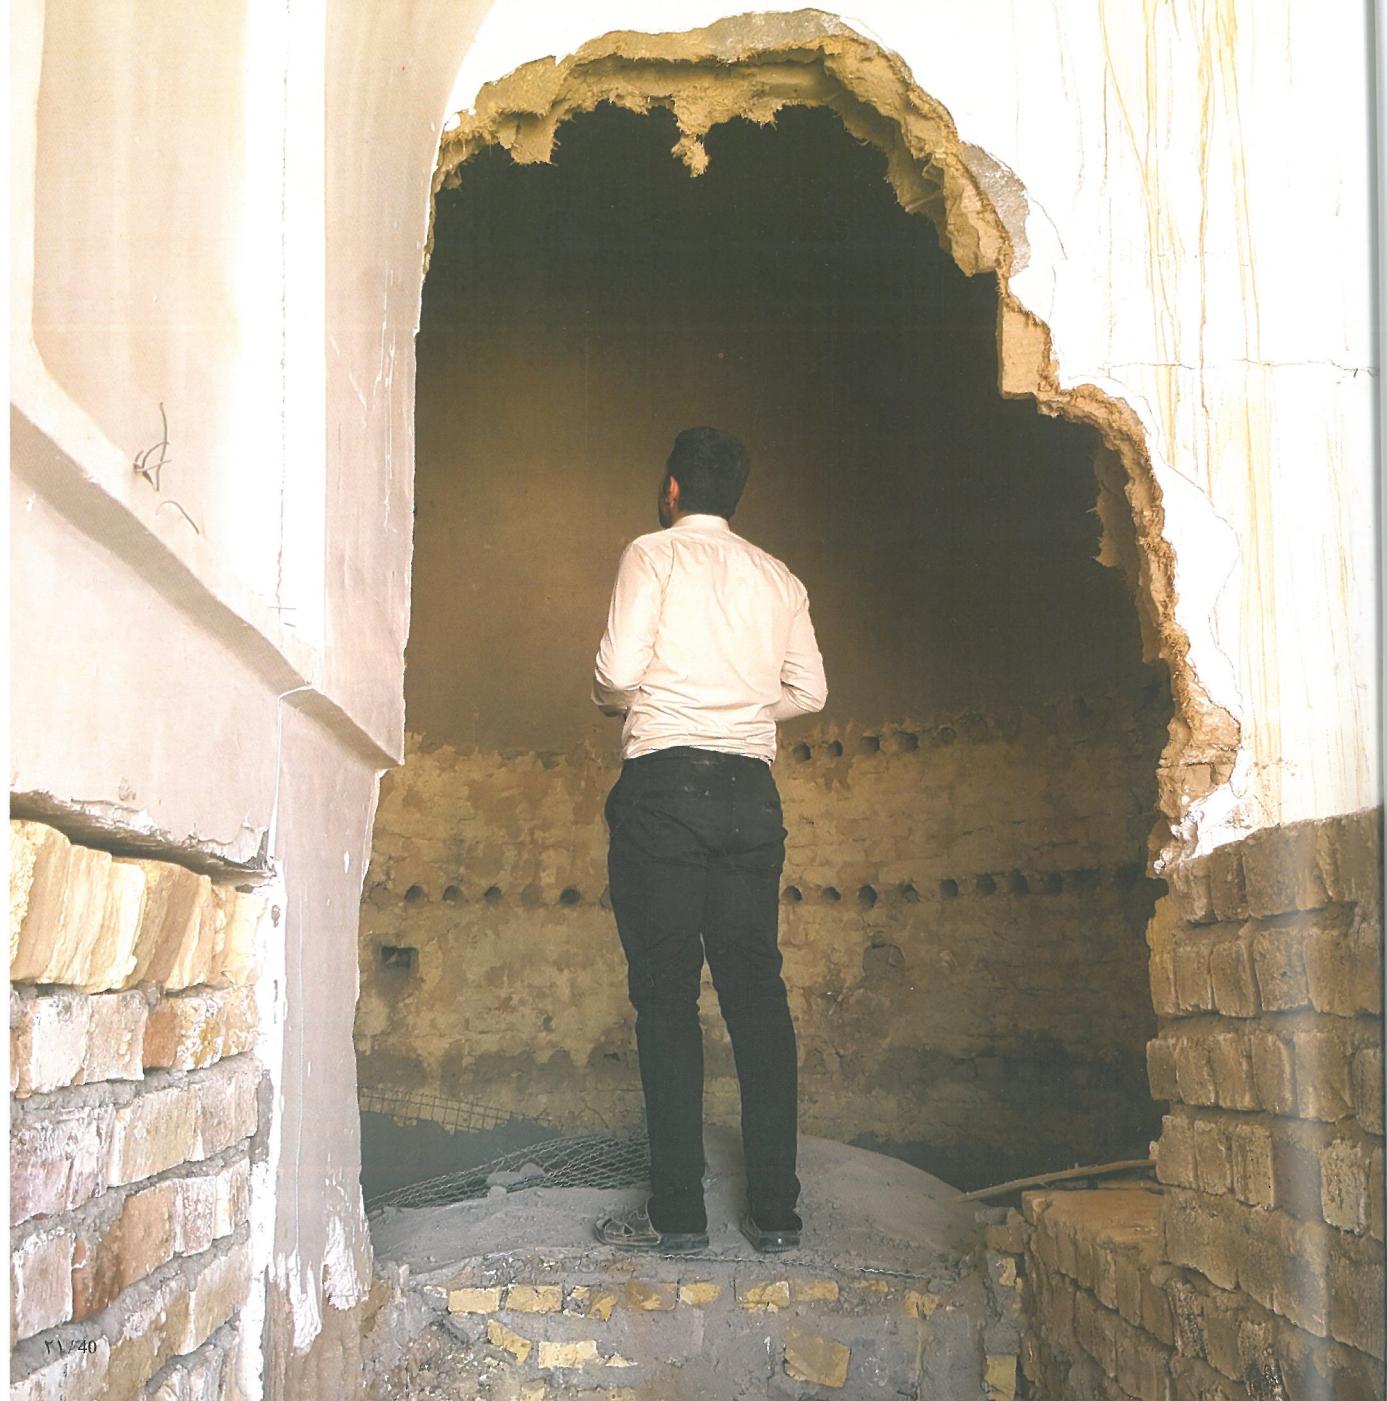
کوره در حال تغییر کاربری به حمام اتاق، سقف بتنی به همین منظور به جای سقف آتش دان کوره ایجاد شده بود.
The kiln being transformed into a bathroom; the concrete ceiling had been made instead of the fireplace roof.

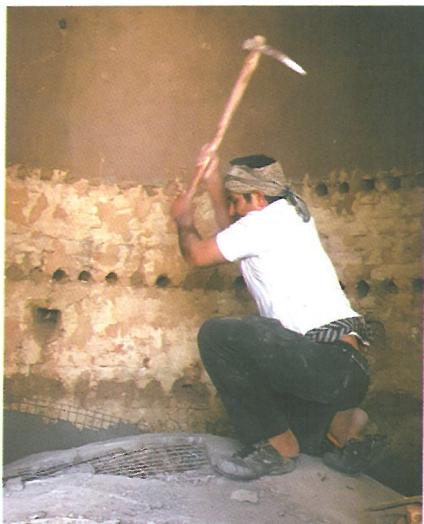
تخریب سقف بتنی، آغاز مرمت کوره
Destroying the concrete ceiling, beginning kiln restoration

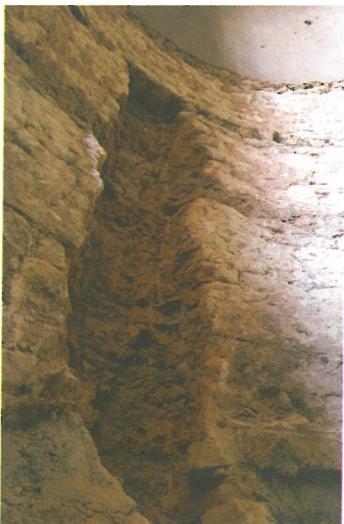
یجاد شکاف در دیوار کوره برای فاضلاب حمام
Making a hole in the kiln's wall for carrying away sewage

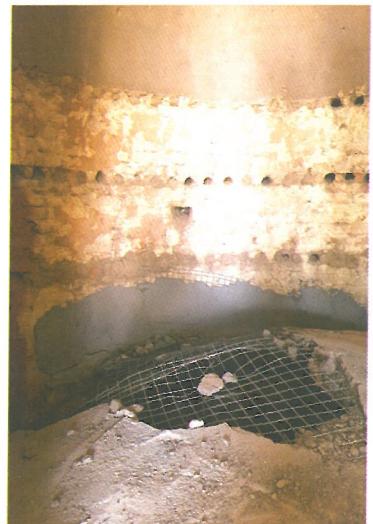
نمایی از سقف بتنی محل آتشدان
A view of the concrete ceiling of fireplace

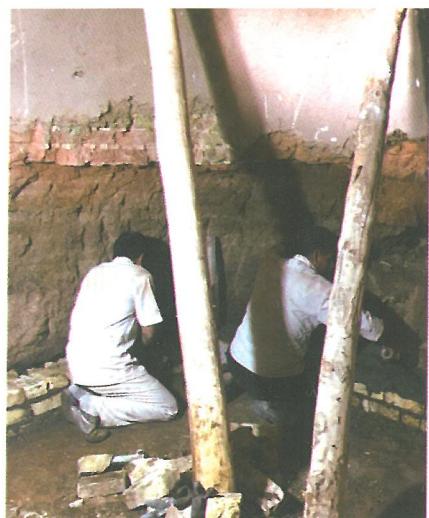
استحکام سازی آتشدان
Consolidating the fireplace

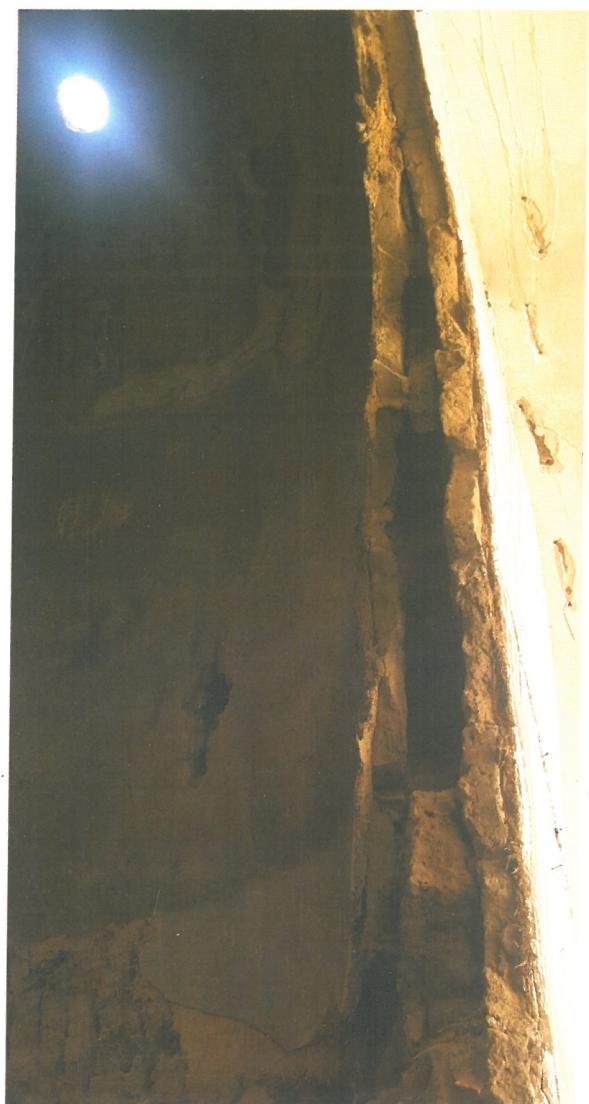
محل اتصال دیوار کوره با دیوار اتاق خانه
The point where the kiln wall joined the room wall

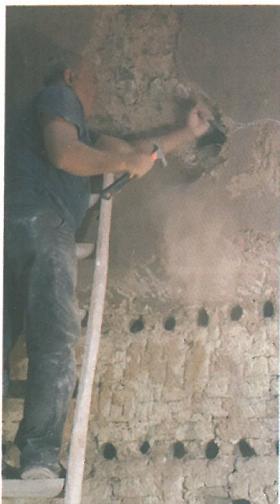
پیدا کردن سوراخ دوم فوکانی هواکش
Finding the second upper hole of the air vent

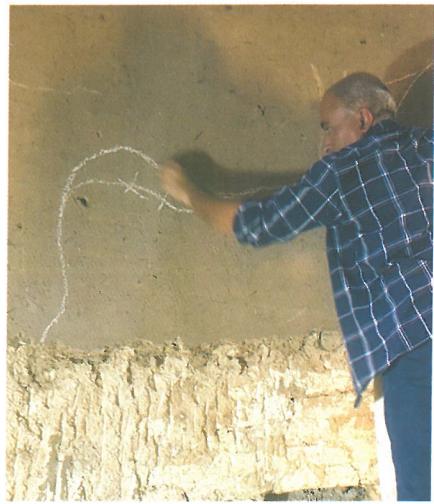
نمایی بعد از لایه برداری کاهگل
A view of the work after removing mud-and-chopped-straw layer

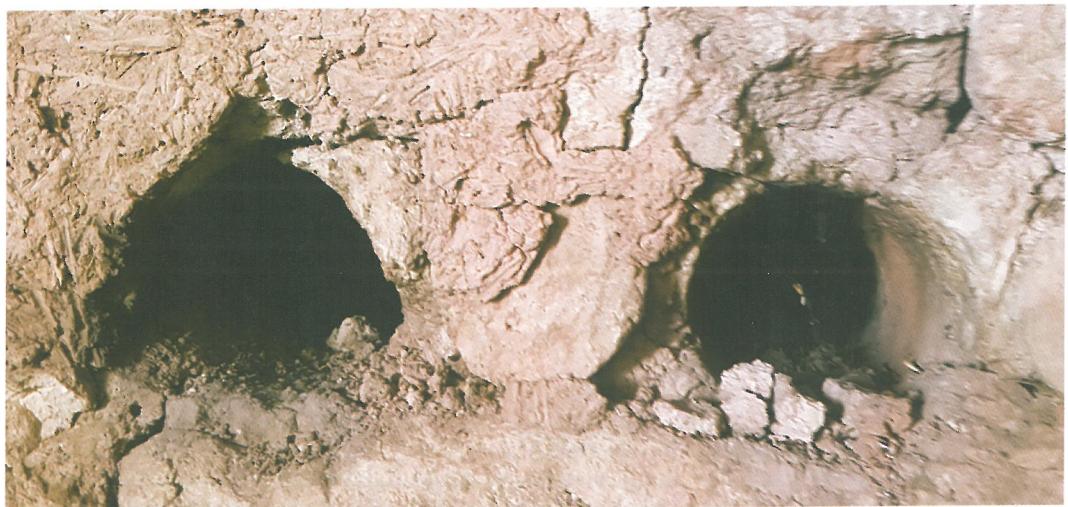
نمایی بعد از لایه برداری کاهگل

A view of the work after removing mud-and-chopped-straw layer

کشیدن کاهگل روی دیوارهای ساخته شده جدید مناسب با دیوارهای اصلی کوره که کاهگل آن پرداشته شد.

Putting mud-and-chopped-straw on the constructed walls proportional to the main walls of the kiln where its mud-and-chopped-straw had been removed

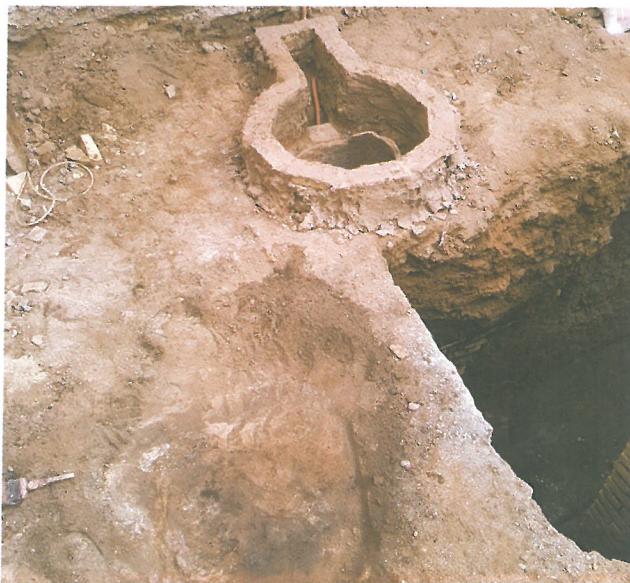
نمایی از کوره از دست رفته تولید مواد در زمان مرمت ساختمان و حفظ باقیمانده یکی از کوره‌ها

A view of a missing kiln of material production at the time of restoration

and preserving the remains of one of them

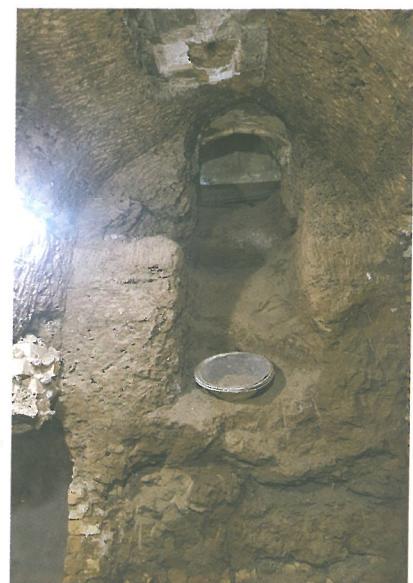
نمایی از بخش جانبی آتش‌دان جهت انتقال هوای زیر آتش‌دان

A side view of the fireplace for transmission of

air to the fireplace

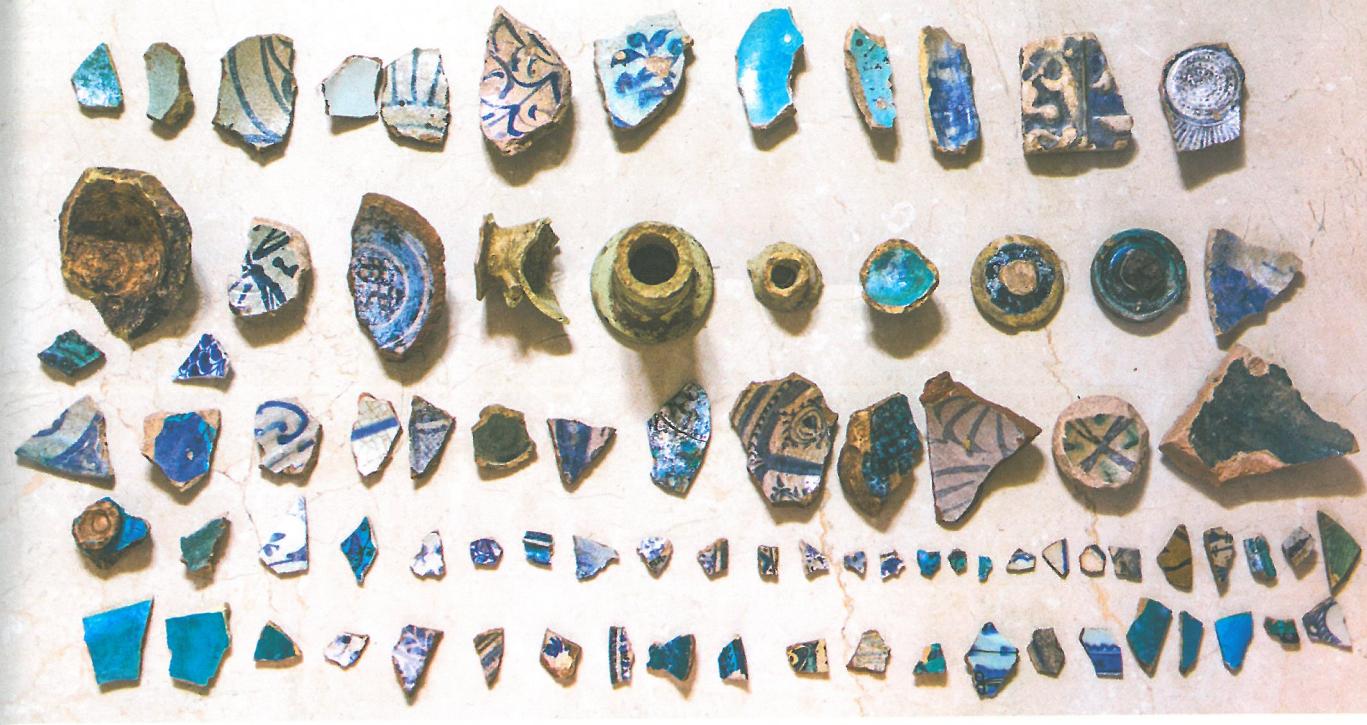
نمونه هایی از یافته های مهم دیگر
Some other important findings

نمونه هایی دیگر از میخ های سفالی
Some other earthenware bars

یکی از میخ های سفالی مهم یافت شده که بازمانده ذوب شده سفال
خمیر سنگ روی آن مشاهده می شود

One of the significant discovered earthenware bars the
remains of melted stoneware can be seen on it

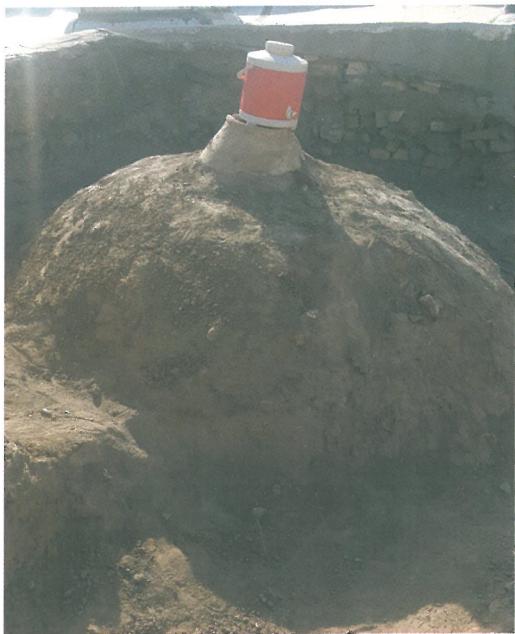
نمایی از سقف گنبدی کوره
A view of the domical ceiling of the kiln

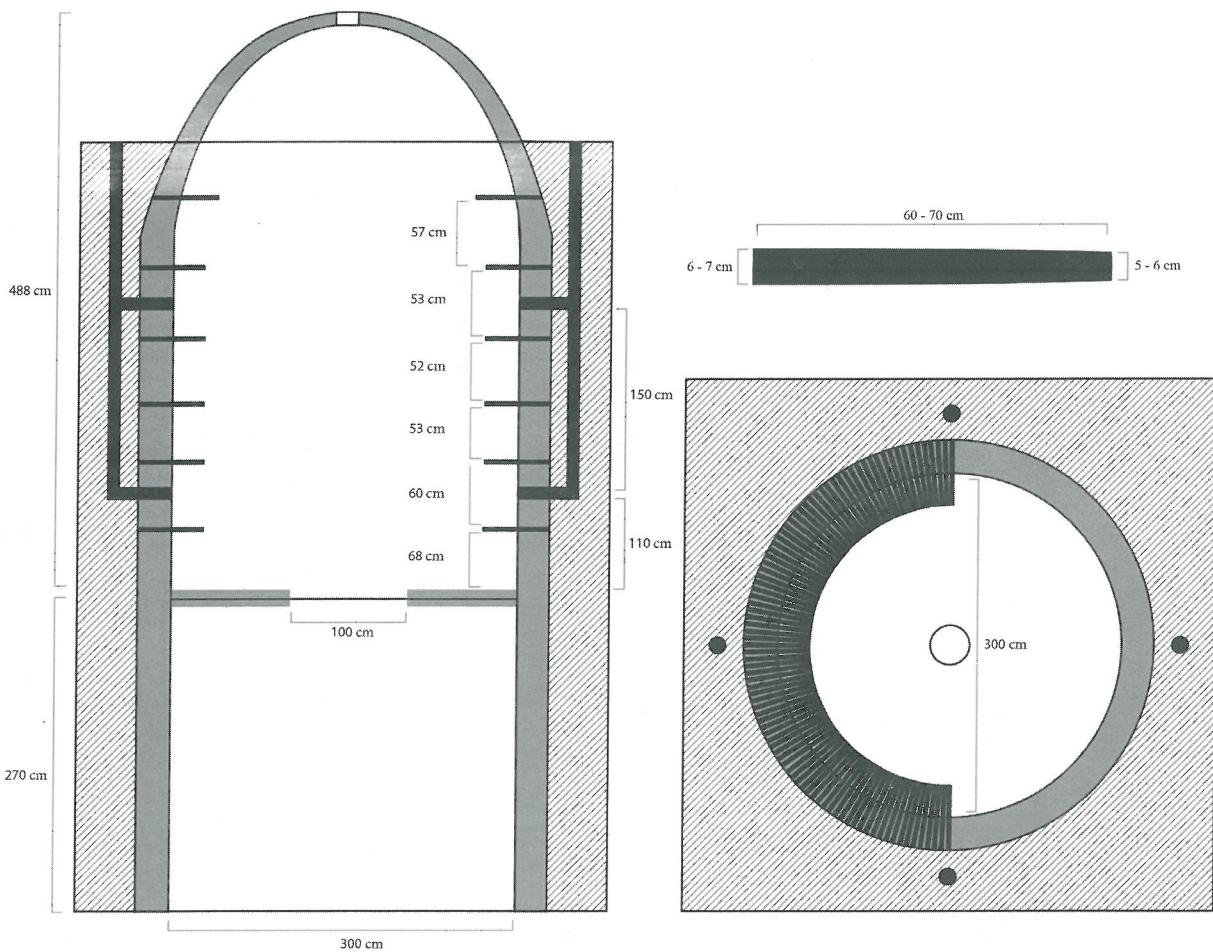
مقطع و پلان کوره، چیدمان ویژه میخ های سفالی به عنوان طبقه و دو سوراخ هواکش منحصر به فرد در طراحی کوره

The section and plan of the kiln, the certain arrangement of earthenware bars as a shelf and two unique air vents in kiln design

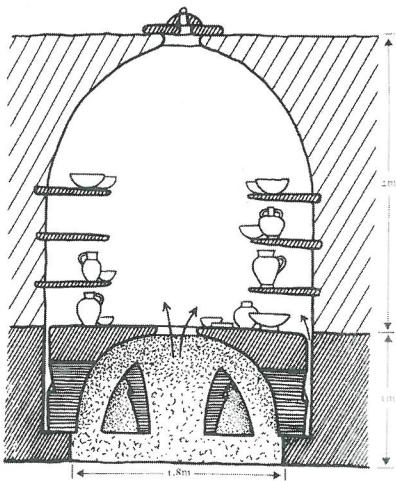
نمایی درست در نشان دادن کاربری میخ‌های سفالی
A correct view for earthenware bars application

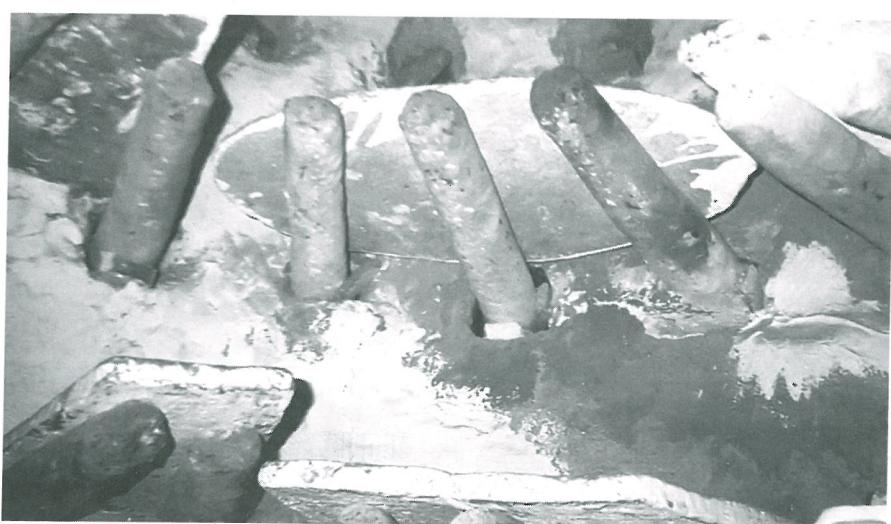
نمایی گویا از میخ‌های سفالی جدا از هم در کوره‌هایی که فاصله میخ‌ها با طبقات سفالی پر می‌شود
A clear view of the separate earthenware bars of kilns in which gaps are filled with earthenware shelves

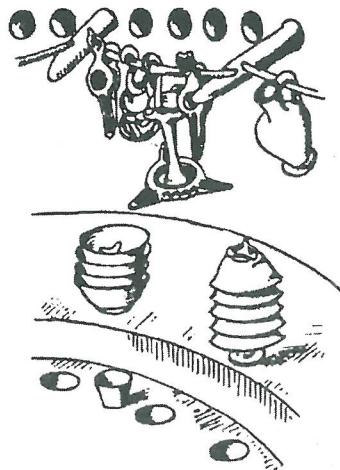
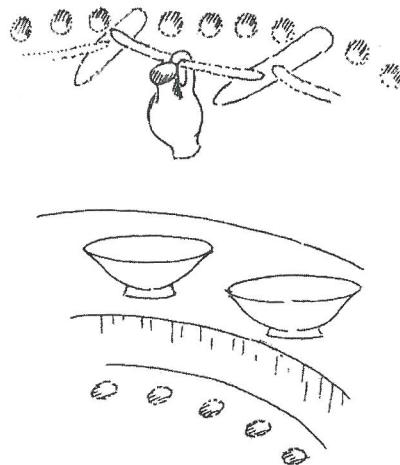
تصویری اشتباه در توصیف کاربری میخ‌های سفالی
A wrong illustration of earthenware bars' application
مأخذ: کامیکش فرد، ۱۳۸۰، ص ۵۰۷.
Source: Kambakhshfard, 2001, p. 507.

تصویری اشتباه در توصیف کاربری میخ‌های سفالی
A wrong illustration of earthenware bars' application
Source: Keblow Bernstled, 2003, p.57.

نمی‌دانم چه کسی برای اولین بار تصویری را منتشر کرده است که در آن ساختار یک کوره مشابه این قبیل کوره‌ها طراحی شده و در درون کوره ردیف‌هایی از میخ‌های سفالی با فاصله هست که چند نمونه ظرف به آن میخ‌ها آویزان شده است.⁷ این تصویر مکرر در منابع مربوط به تاریخ سفال ارجاع داده می‌شود؛ در صورتیکه آشکارا نشان از یک اشتیاه علمی در خصوص نحوه چیدمان سفالینهای با میخ‌های سفالین تعییه شده به عنوان طبقه است. کسانی که کار سفال می‌کنند می‌دانند آویزان کردن ظروف دسته‌دار به نحوی که در تصویر مرتبط با صفحات بعد مشاهده می‌شود در صورتیکه برای بیسکوئیت کردن باشد غیرممکن است، زیرا در چنین حالتی اغلب به علت مقاومت کم گل وزن کوزه هنگام آویزان کردن و به ویژه در دمای بالا هنگام پخت موجب سقوط و شکستن آن‌ها می‌شود. از طرفی در صورتیکه منظر ظروف لعاب‌دار باشد نیز غیرممکن است زیرا در این صورت نیز لعاب روی دسته به میخ‌های سفالی می‌چسبد و هنگام سردشدن نمی‌توان آثار را از میخ‌های سفالی جدا کرد. همچنین اگر به متن ابوالقاسم نیز برگردیم او مذکور می‌شود که سفالینهای را برای پخت روی این میخ‌ها می‌گذارند. یافته‌های ما در کوره مورد نظر نیز این مهم را تأیید می‌کند. در نگاه نخست به نظر می‌رسد این میخ‌ها کاملاً گرد هستند در صورتیکه توجه دقیق به آن‌ها نشان می‌دهد یک سطح آن‌ها و دقیقاً قسمت بالای آن بخش که در داخل کوره است صاف و از حالت استوانه‌ای خارج شده و این دقیقاً جایی است که به سمت بالا است و می‌توان مقطع ظروف را روی آن‌ها گذاشت. از طرفی دیگر ردیف میخ‌های سفالین جامانده در کوره نشان می‌دهد برخلاف تصویر کتاب‌ها بین میخ‌ها فاصله‌ای نیست و در حقیقت این میخ‌ها کنار هم تشکیل یک صفحه و طبقه یک پارچه را نشان می‌دهند. من نه تنها در این مکان بلکه در چند نقطه دیگر در کاشان این میخ‌ها را دیدم و جمله آن‌ها همین ویژگی را داشتند. به کار گرفتن این میخ‌های سفالین ساختار طبقات داخل بسیاری از کوره‌ها را تا سده‌های متولی تشکیل می‌داد. به همین دلیل به نظر می‌رسد با این شواهد باید از این پس در استفاده از این تصویر تجدید نظر صورت گیرد.

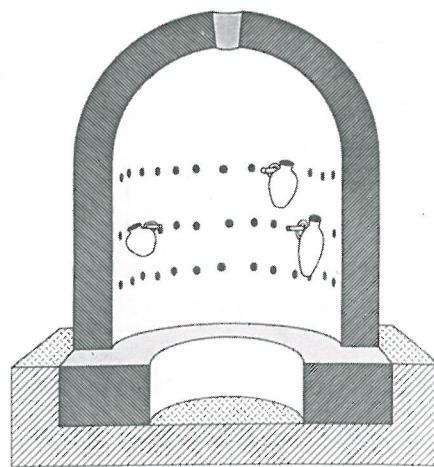
تصویر اشتباه در توصیف کاربری میخ‌های سفالی در منابع مربوطه، متساقانه منبع کتاب را ثبت نکرده‌ام
A wrong illustration for earthenware bars' application in related sources; unfortunately, I did not record the resource

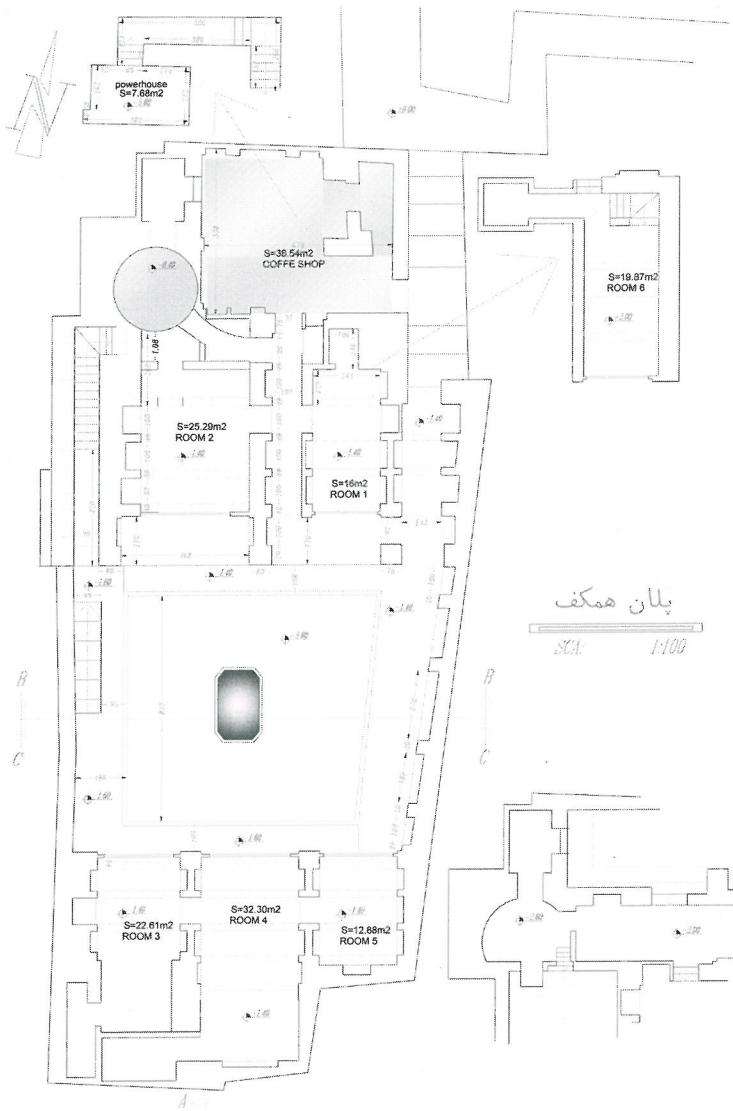
پلان طبقه همکف و موقعیت کوره و کارگاه (کافی شاپ فعلی) در آن که بصورت هاشور مشخص شده

Ground floor plan and the location of kiln and workshop (the present coffee shop) on it determined by hatching
